Anglican Church of Saint Paul the Apostle – Manuka

Conservation Management Plan

November 2015

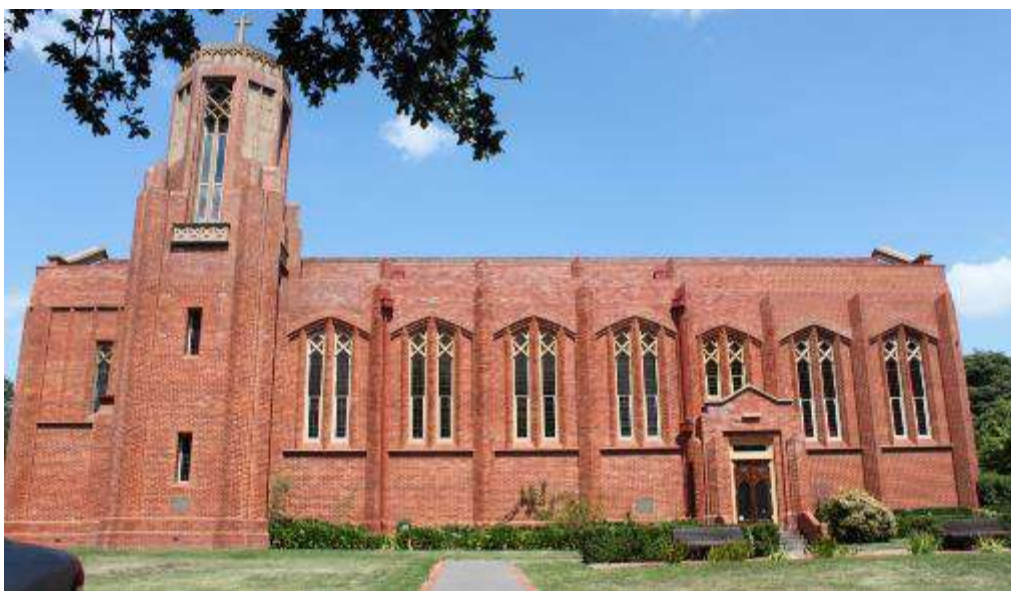
North elevation 2015. Note angular tracery in windows. Photo: Pip Giovanelli 2015.

The building has been erected in three stages each faithfully and sympathetically following the original design. The junction between the stages is discernible on close inspection due to slight variation in colour of mortar. Bricks in the 2001 phase are crisper than those of the older parts. Each section is also conveniently marked with its own foundation stone. The central three bays plus that of the northern entry portico were constructed first (1938-39), followed by an additional bay, the tower, sanctuary and vestry second (1955) and the western two bays last (2001). The octagonal upper section of the bell tower (or lantern) features cement panelling and decorative treatments set within the brickwork, around the window and as a capping or parapet to the tower top.

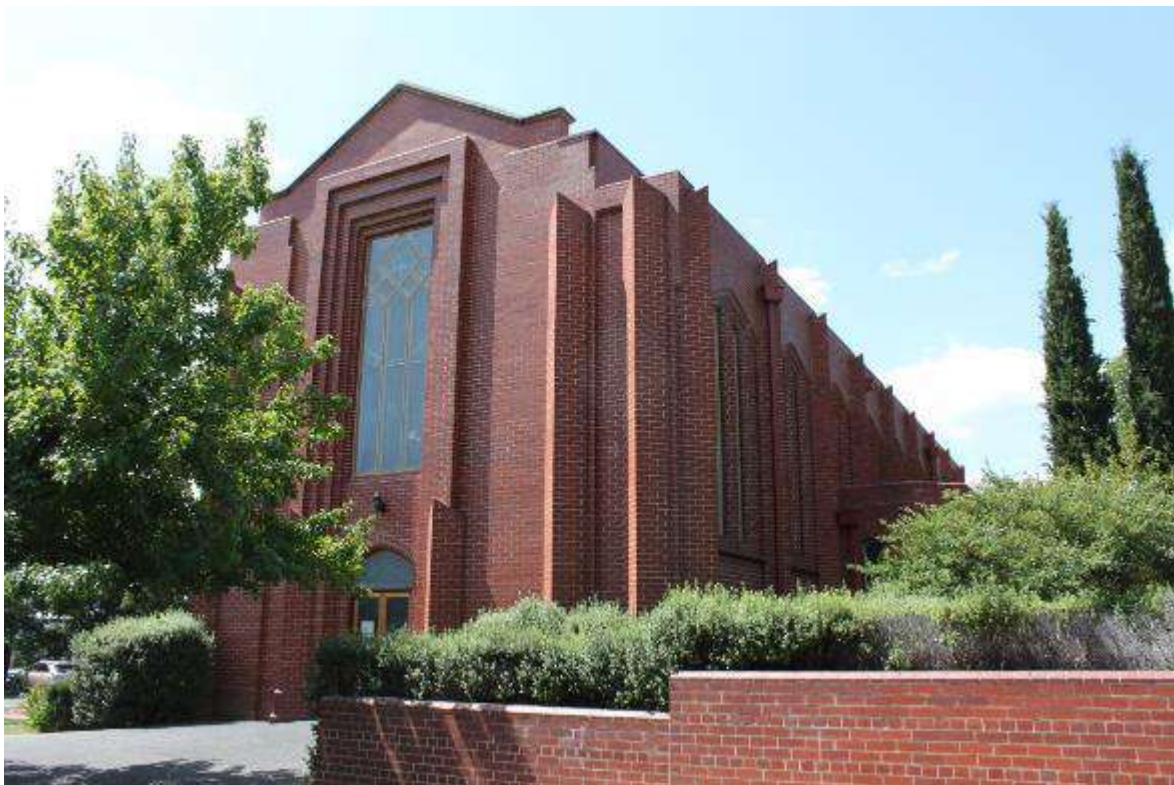
Western elevation completed 2001. Brickwork is crisper and colouration more even than in the earlier phases. Photo: Pip Giovanelli 2015.

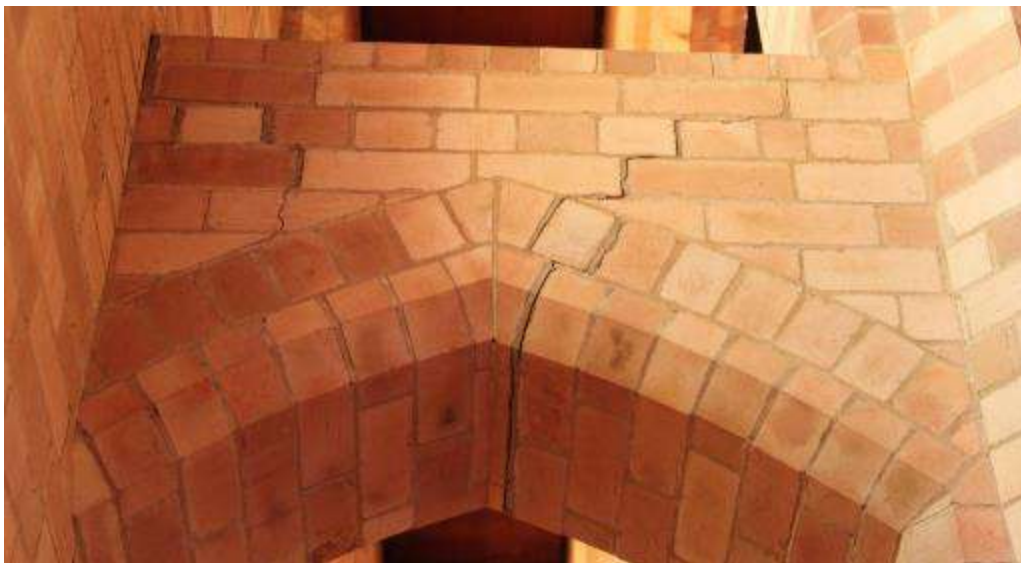
Cracks in cross arches. Photo: PG 2015

arched brickwork, in many of which cracks have appeared over the years. Some cracks have been filled, only to show evidence of further movement and it is recommended later in this report that the cracks be investigated and monitored by a structural engineer. The internal arches are slightly curved and pointed in the gothic manner however the internal detailing is not so redolent of Art Deco treatments as the exterior.

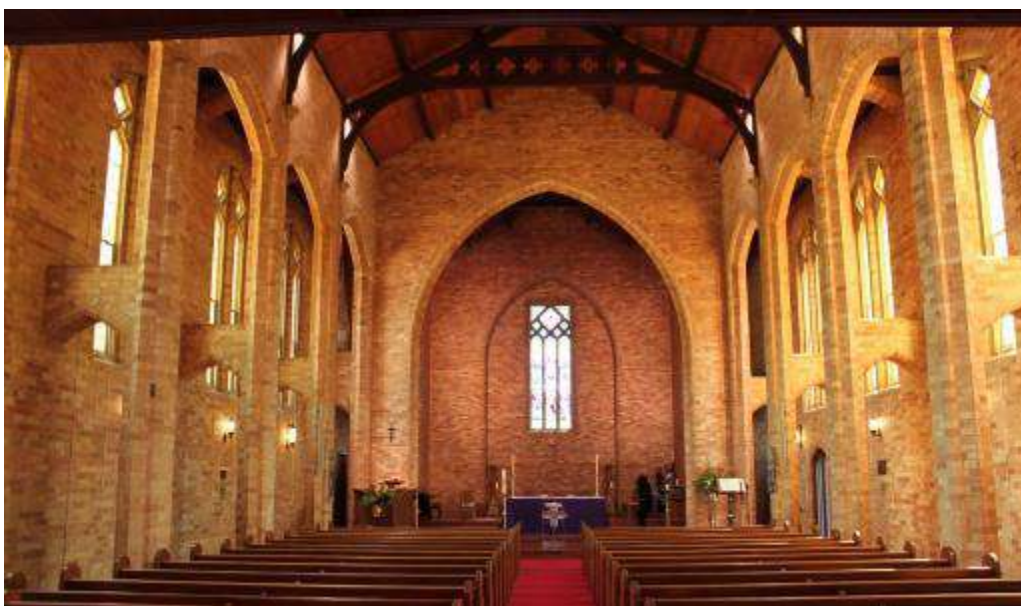
Interior view east to the sanctuary. Photo: PG 2015

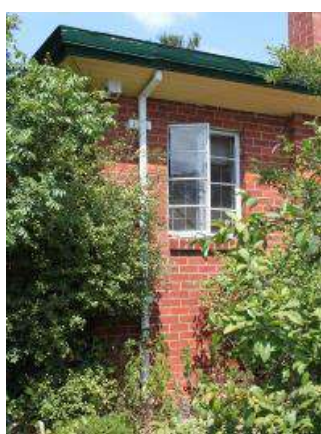
Old rectory exterior. Note the gutters are behind the fascia boards. Photo PG

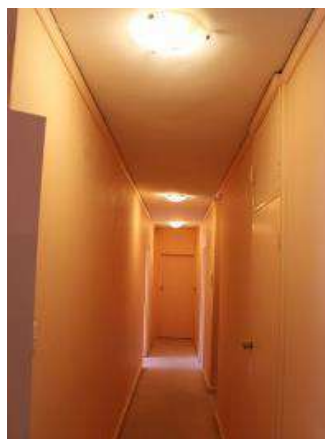
Internal corridor showing typical colour scheme and detail. Photo PG

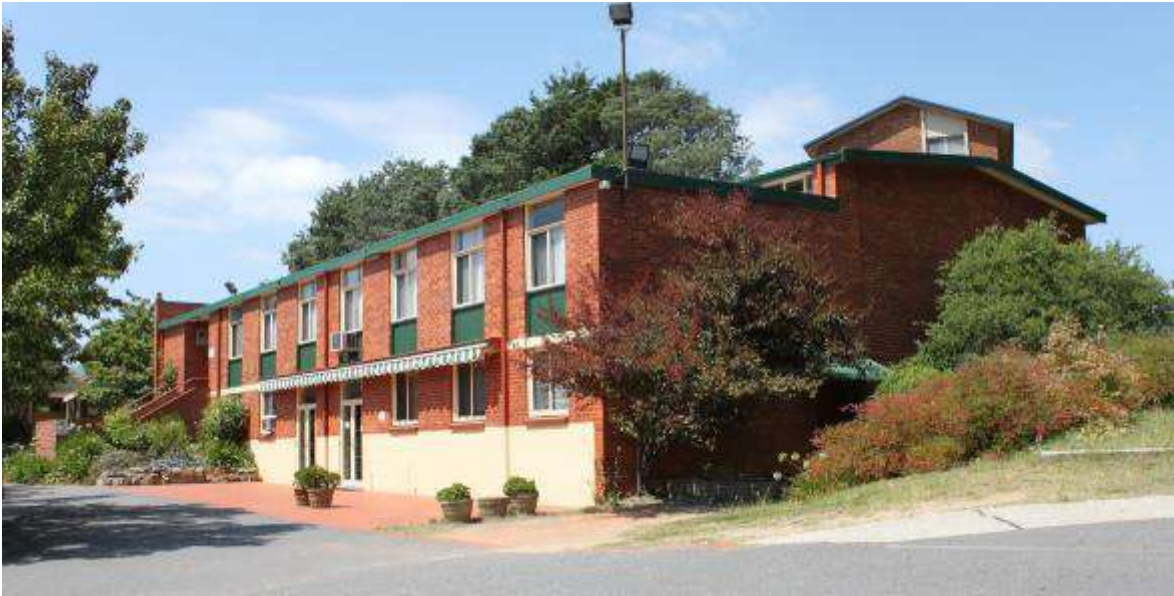
The office and op-shop are located at ground level with hall to the rear. Photo PG 2015

Internally the hall and office building appears in fair-to-good condition although there is some deterioration of ceiling in the upper entry foyer. Hall interior walls are brick, ceiling is manufactured sheet supported on welded steel-web trusses. Floors are timber. The ground floor in the office section is a concrete slab on ground, walls are painted brick and the first floor appears to be a suspended concrete slab integrated with concrete beams.

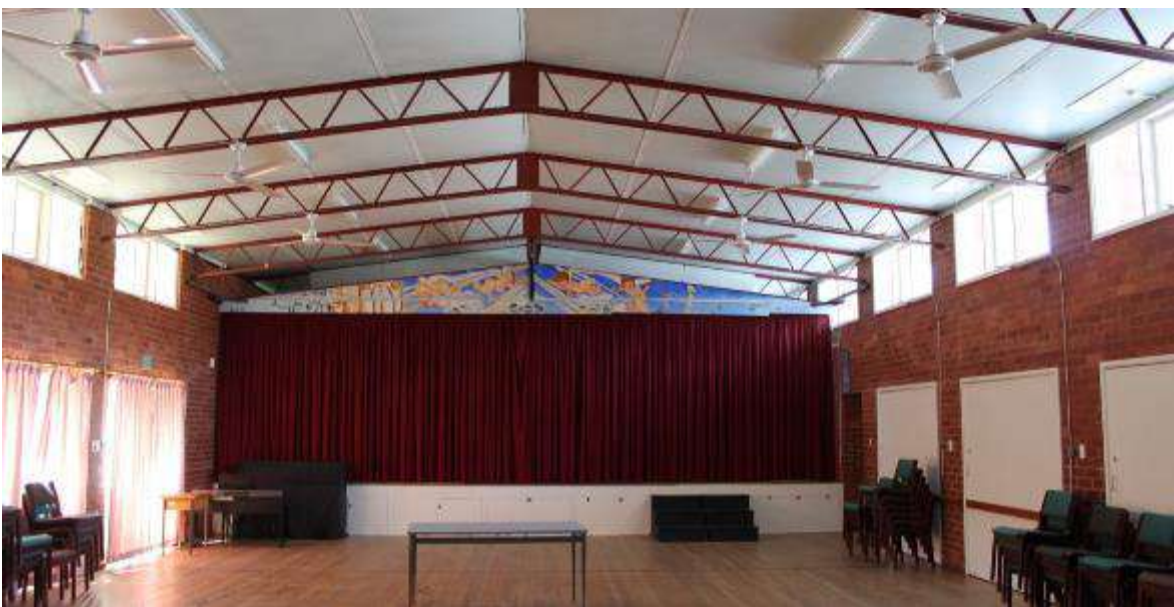
The hall is at the rear of the upper level. Photo PG 2015.

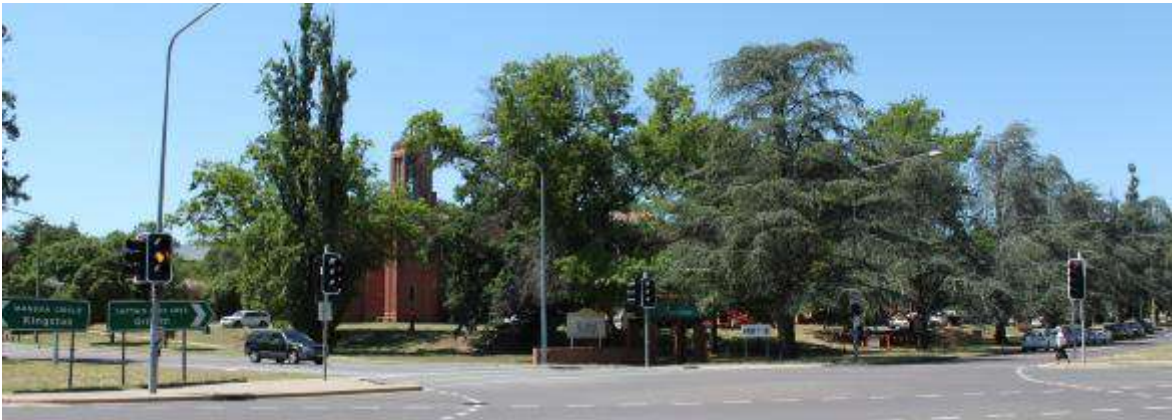
Deciduous and evergreen trees block views of the church for much of the year. Photo PG 2015

Some of the lower branches on the oaks hang low and when in leaf obscure views through to the church. It is recommended that a careful pruning of the lower branches be undertaken periodically to enhance the views of the church to pedestrians and motorists.

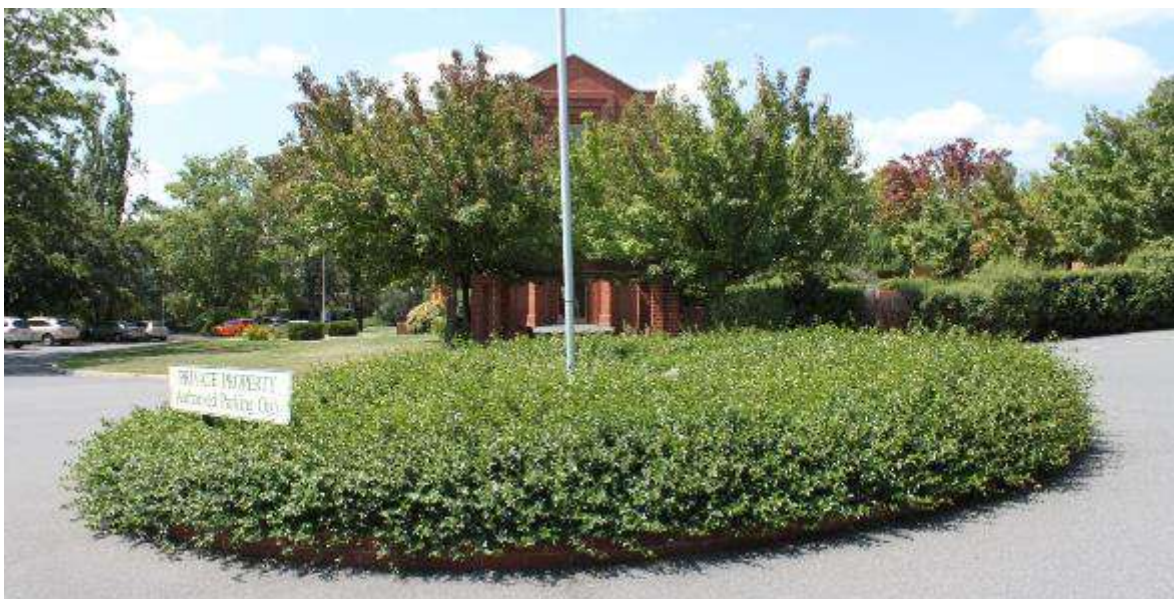
Western axis runs from the turning circle, through the lych gate, and between the avenue of trees to the western door and through the nave to the sanctuary. Photo PG 2015.

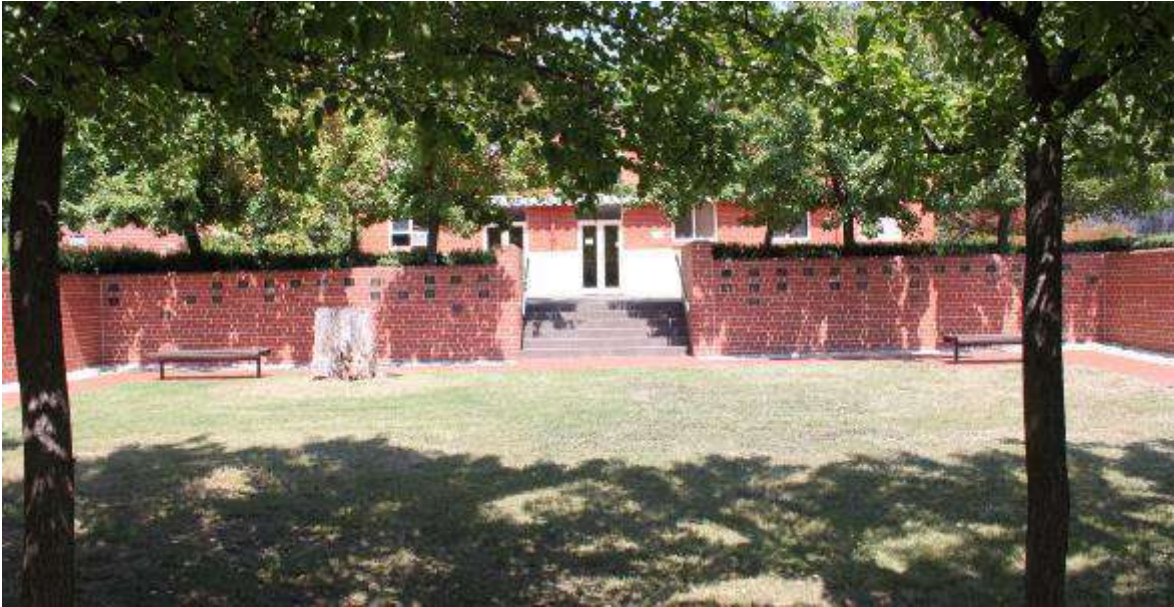
Garsia garden with memorial plaques and stair to upper road and office. Former tree stump is visible to left of stairs. Photo: PG 2015.

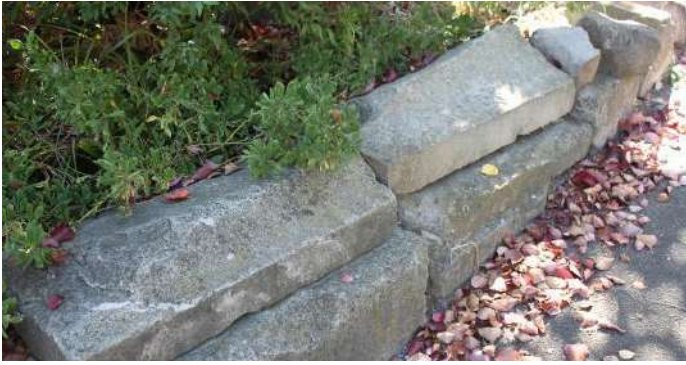
Carved stones adjacent to new rectory. Note that a series of shaped stone sit on those evident in the earlier image of the new rectory garden. Photo PG 2015.

One border to the garden is defined by a series of carved stone blocks, possibly from different sources. Their origins have not been established but some may have been a former parapet on St Pauls, removed when the western extension was undertaken. It has also been suggested that some may have been brought on site from elsewhere. Either way they are deemed to have some heritage value and should be retained on site for landscaping or other appropriate use.

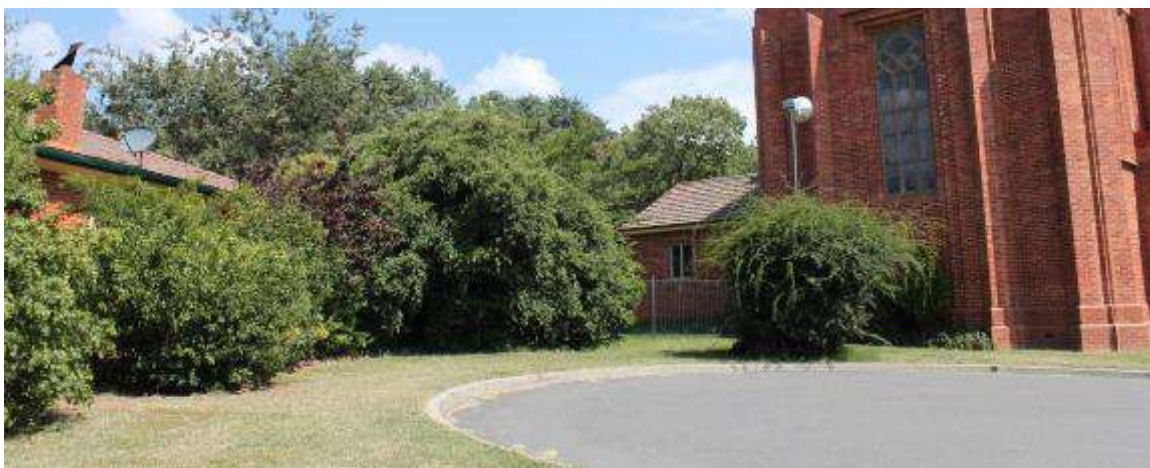
Landscaping at east end comprises turning circle, grassed area and mixed shrubs around the light pole.

The space at the eastern end of the church comprises a kerbed turning circle, mown grass, an unkempt cluster of shrubs around a spotlight and a modern metal fence. These elements do very little to enhance the appearance or setting of this end of the building and provide an opportunity to enhance both landscape and lighting, at the same time as improving views from Canberra Avenue.

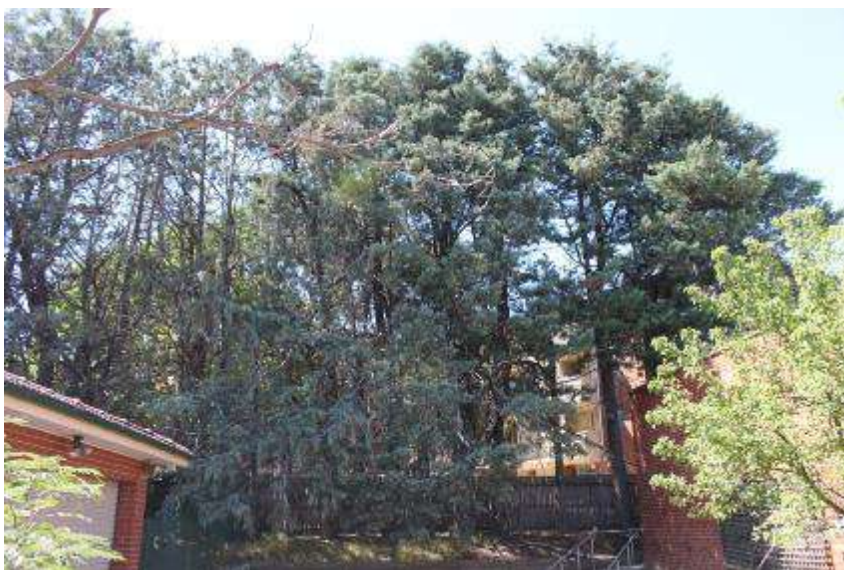
Boundary planting of *Cupressus arizonica*. Note the trees on the left have been pruned at their mid height and are now poor specimens

On the southern boundary, the land rises steeply with a series of housing units and government flats located on the properties beyond. A dense screen of *Cupressus arizonica* trees (attributed to Hobday 1940, HTRp55) were planted on the boundary presumably to provide privacy to the church site and to screen the flats. In 1982 the church removed some of the pines on the southern property boundary as their roots were causing continued damage to the driveway of the adjacent flats (HTR p 61). At some point in time a number of the remaining trees were lopped heavily at their mid-height and although they have regrown are noticeably weaker. The species is not rare and the planting as a group is not outstanding or distinctive. The trees are not considered to have heritage significance other than that they are a component of the site that has been in situ for some time. Their primary value is as a backdrop to the site that screens out the flats when viewed from certain angles. In *Trees of Canberra* Lyndsay Pryor notes that *Cupressus arizonica* is *rather short lived – about 30 – 40 years* and is *useful as a fairly quick medium term screening* (LP p23).

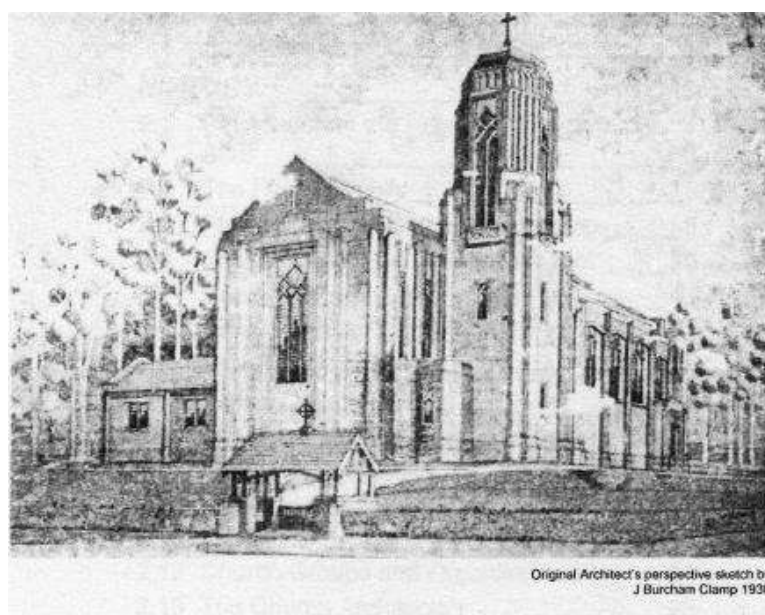
Original Architect's perspective sketch by J Burcham Clamp 1938. Sourced from *St Paul's Anglican Church CMP* by EMA.

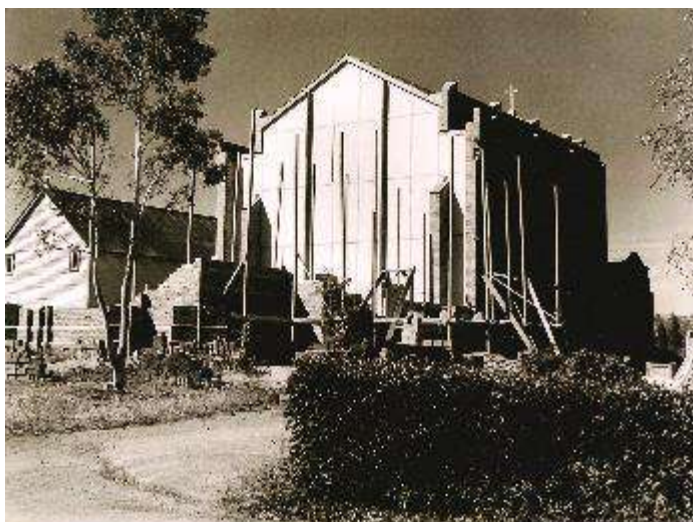
Extensions 1955 (The old Mission Hall can be seen in the left background)

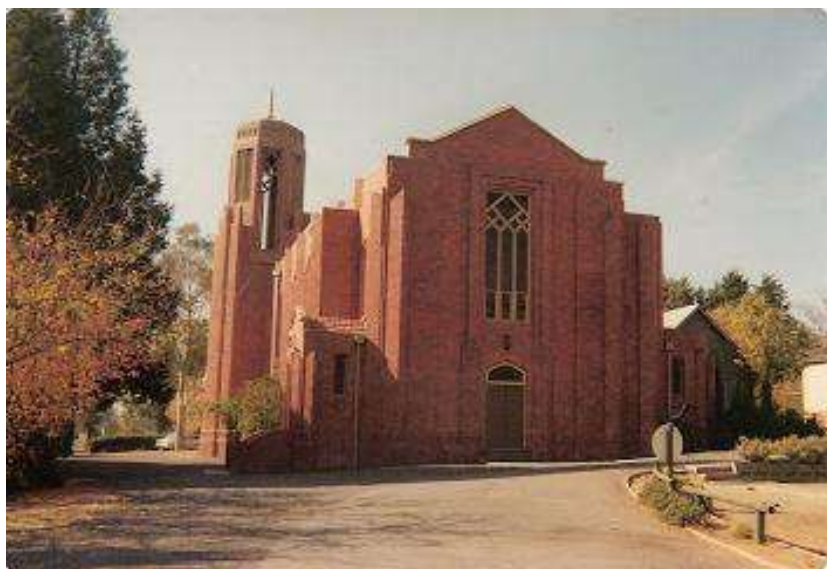
West end prior to 2001 extension. Source National Trust ACT Photo collection

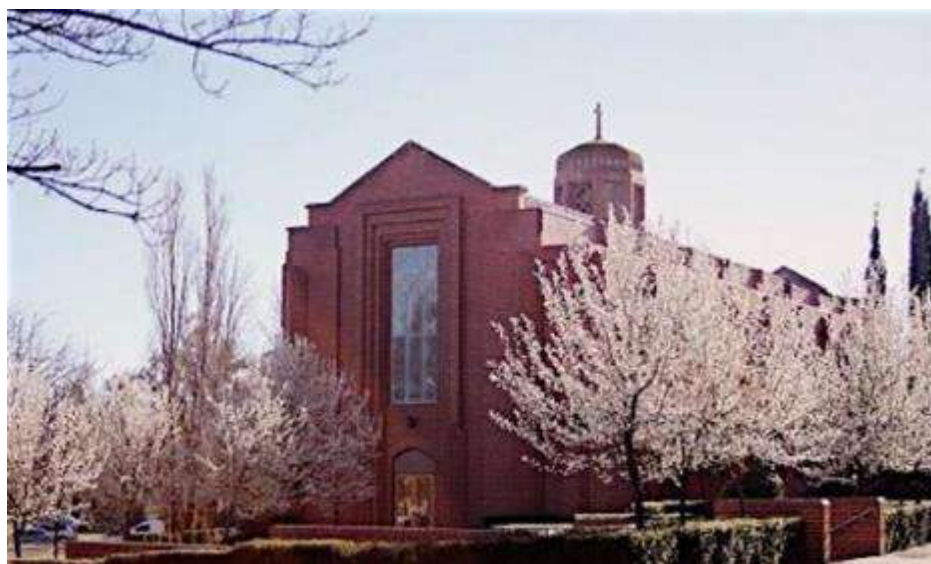
St Pauls after completion of western extension

A new master plan by Colin Stewart Architects embraced two additional bays, a revamped and extended gallery, a dismantled and restored organ, and additional congregational seating. The extensions were completed, blessed by Bishop Browning, and opened by the Governor-General, Dr Peter Hollingworth late in 2001. The debt, exceeding \$770,000, was paid off during the incumbency of the Reverend Dr Scott Cowdell (2002-2007) who also saw a set of bells installed in the tower and the church grounds remodelled and improved (Braggett, 2008, Chapter 14).

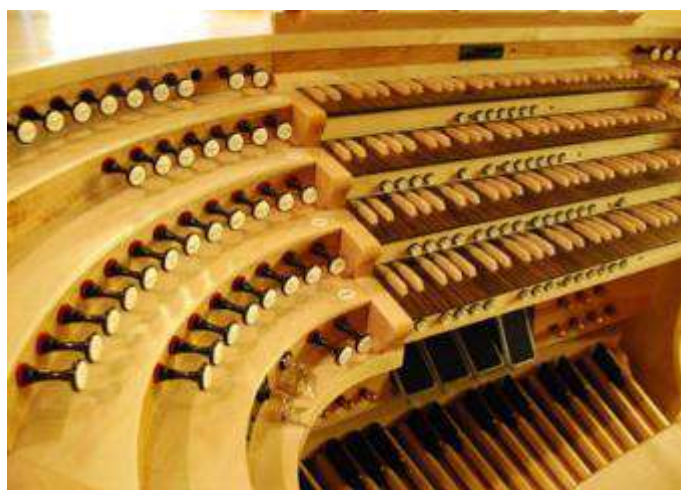
New Organ Console

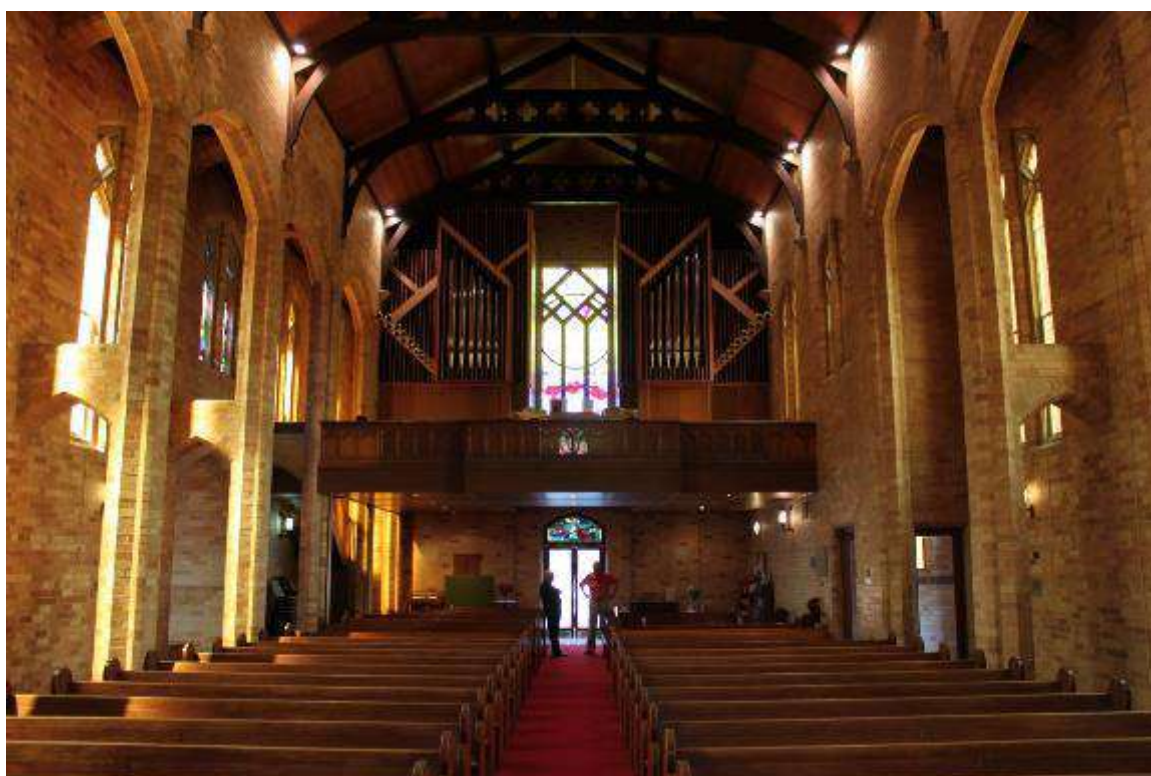
Interior view west to organ and choir loft. Photo PG 2015

Because of past water damage to the keyboard and pipes, the pipe organ had to be dismantled and sent to Sydney for restoration in 1988. A gallery was constructed at the back of the church at a cost of \$34,000 and the pipes of the restored organ were arranged in an aesthetically pleasing fashion in a wood casing in the loft in 1990. While more work remained to be done on the organ, the music enhanced worship and was more appropriate to a city church. The total cost was \$103,000. Moreover, a series of musical dramas further extended city interest in the church.

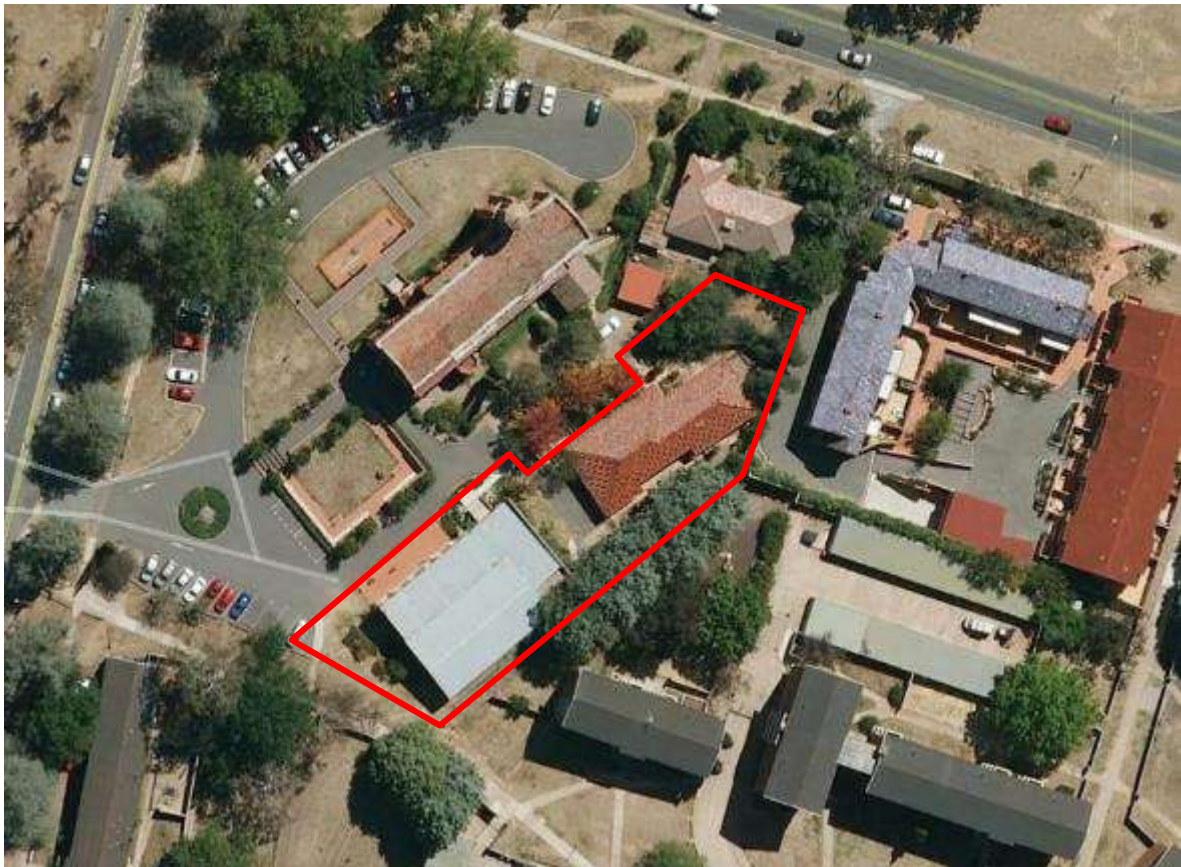
Proposed maximum building envelope within the present church boundary outlined in red. (Refer Conservation Policy 9.6, point 23).

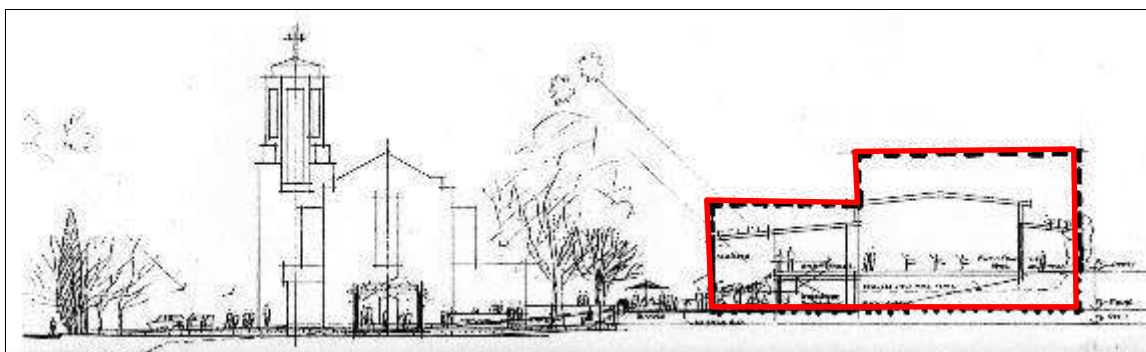
Maximum building envelope shown in red laid over a 1998 sketch by Colin Stewart Architects. A section through the existing hall and office assists an understanding of possible bulk of new development. Maximum height of lower section should not exceed the height of the church side aisle. Maximum upper height should not exceed the church's upper ridgeline. Development closer to Canberra Avenue to be the lower height. Maximum height of development forward of vestry (towards Canberra Avenue) should be no higher than the vestry ridge.
